## DK Motor clean up

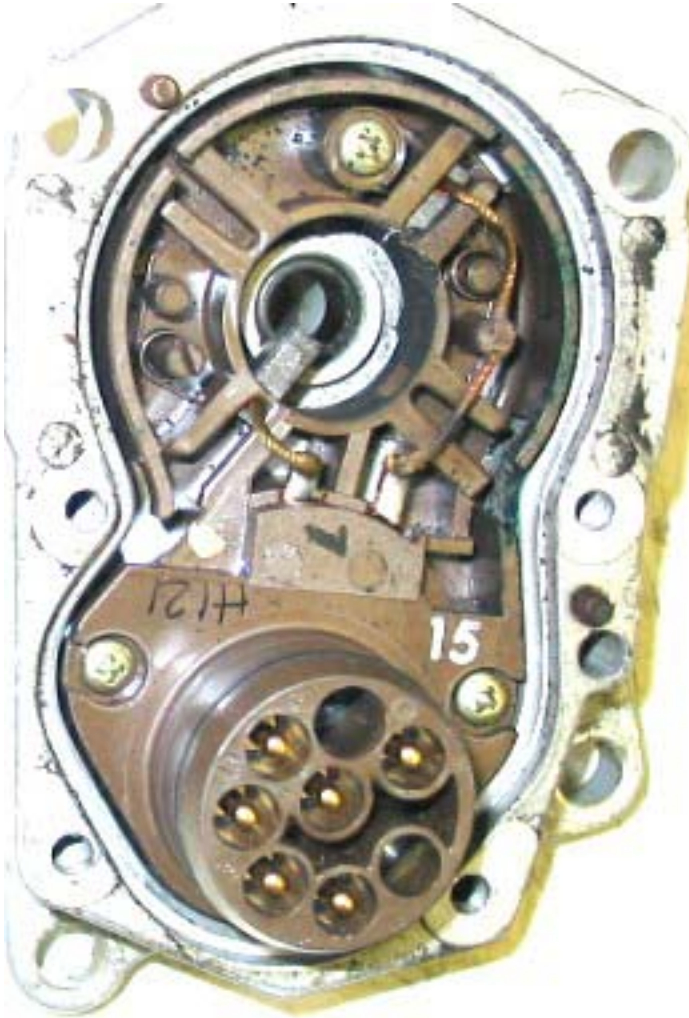
I then opened up the DK that did not move when 12 volts was applied to pins 3-5. this is what I found.

One brush was stuck out and would not make contact with the commutator.

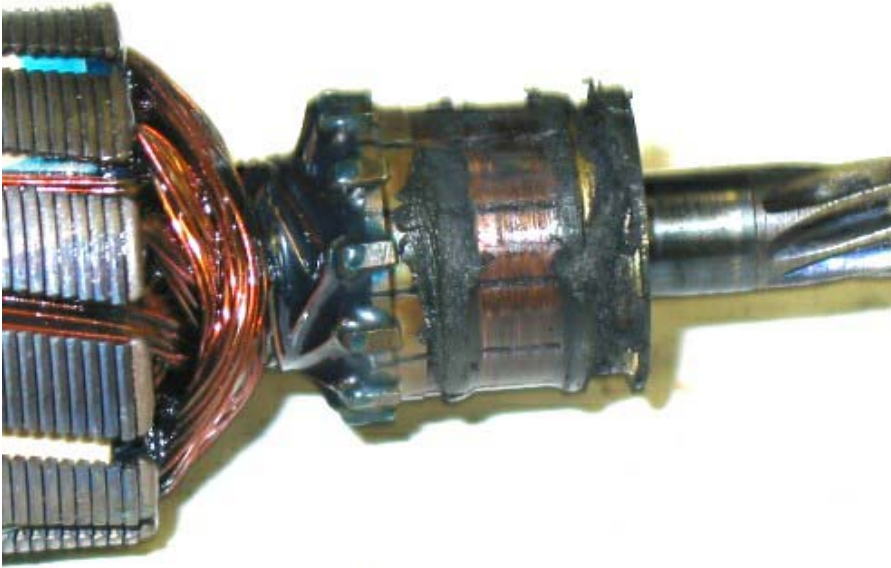
This is what the commutator looked like when removed

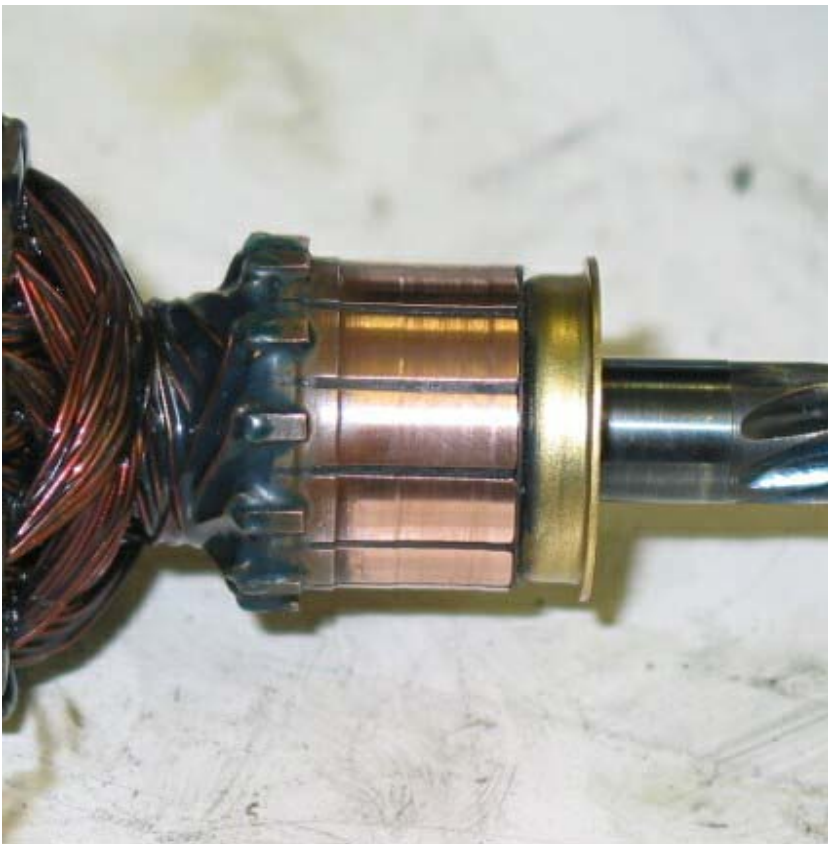
After cleaning looked like this

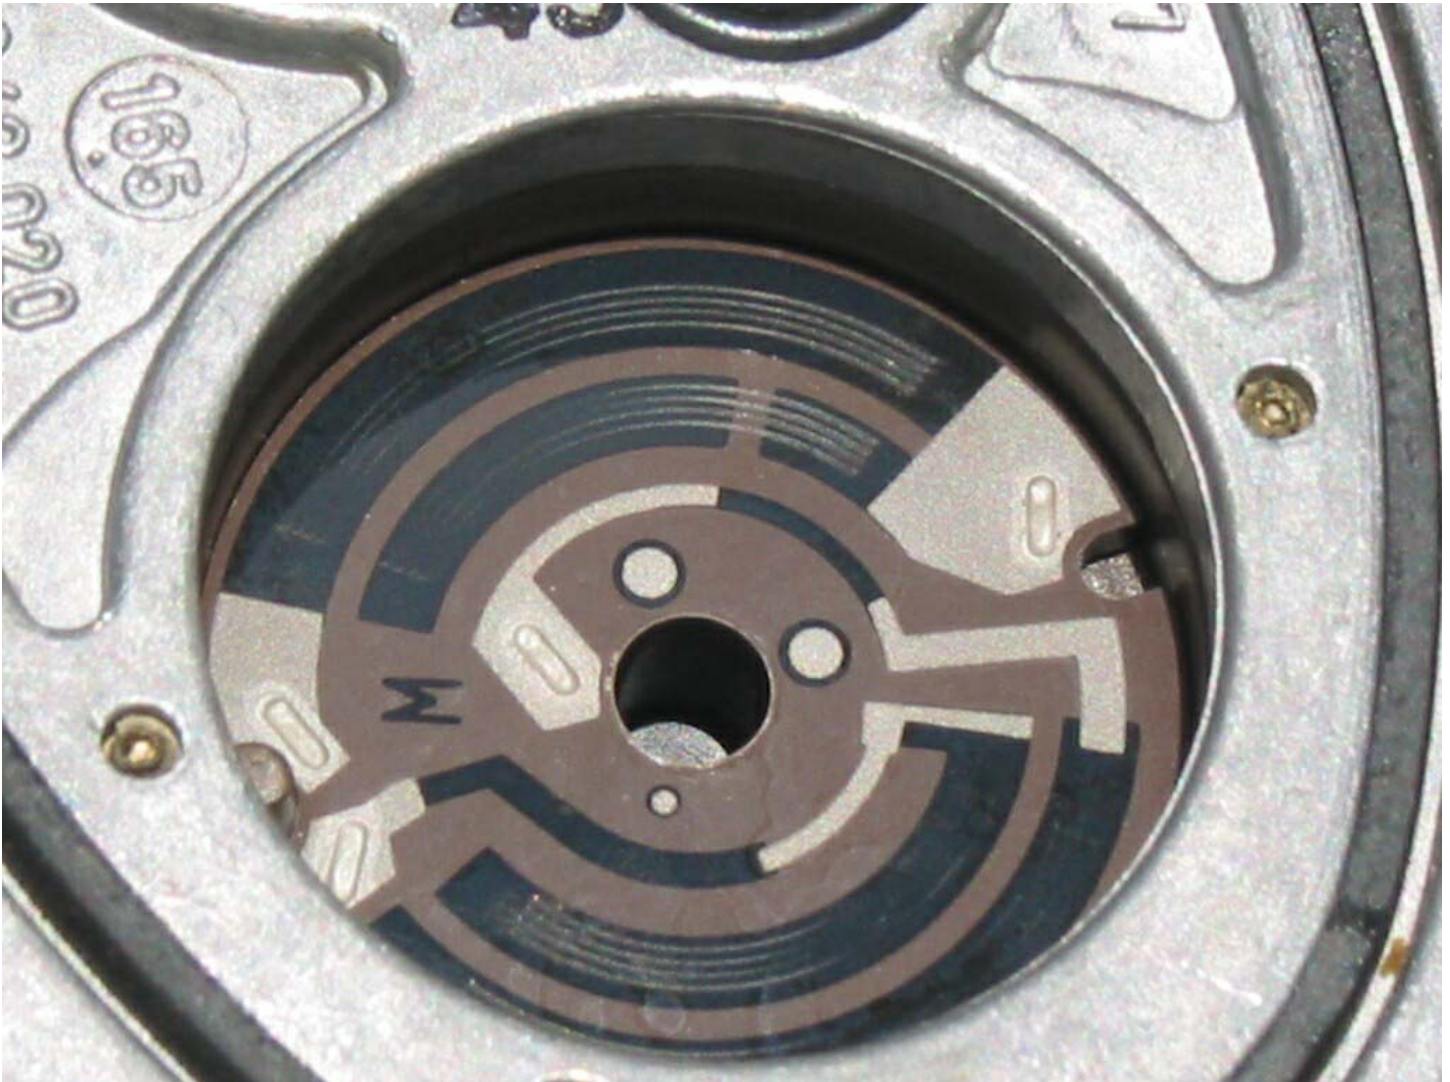
One thing that caught my eye was the condition of the feedback resistor set up. This is part of the DK that tells the EML how far open or what the position of the butterfly valve is. There is also a resistance that opens up at about 10 degrees of movement of the throttle plate. (between pins 1-7)

The black stripes are resistance material that is deposited on a substraight. Attached to the throttle body shaft is a set of wipers that make contact with the resistance material. The wiper position is preset at the factory. As the throttle plate moves, the wipers also move along the resistance material and the resistance value changes.

Major concern on this DK set is the amount of wear on the resistance material. When the wipers wear thru the resistance material, the resistance readings sent back to the EML will not longer be correct or may fluctuate wildly during throttle plate movement. This certainly would set off the EML light and may initiate “limp home” mode.
